Subject: Smoky Canyon Mine Remedial Investigation/Feasibility Study  
Dinwoody Material Source Investigation Report

**To:** Jeff Hamilton, Environmental Engineering Manager; Grant Williams, Senior Mine Engineer  
**From:** Katie Wilkes, Geologist  
**Cc:** Neil Musilek, Engineering Manager; Casey McCaslin, Survey  
**Date:** November 27, 2018  
**Re:** **Dinwoody Material Source Investigation Report**

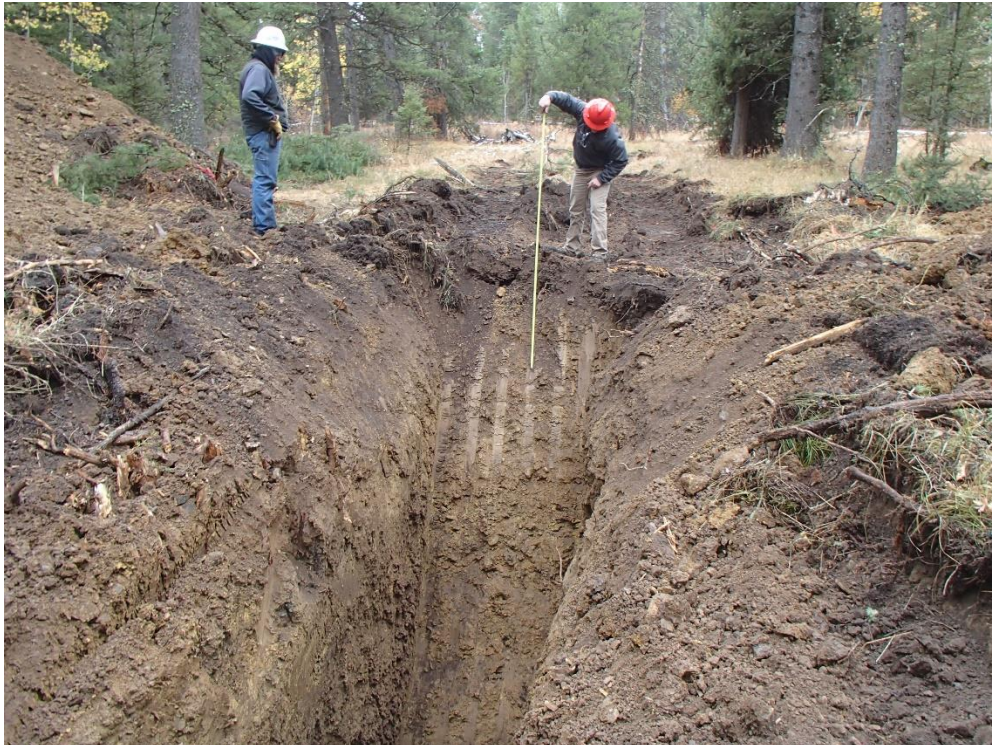
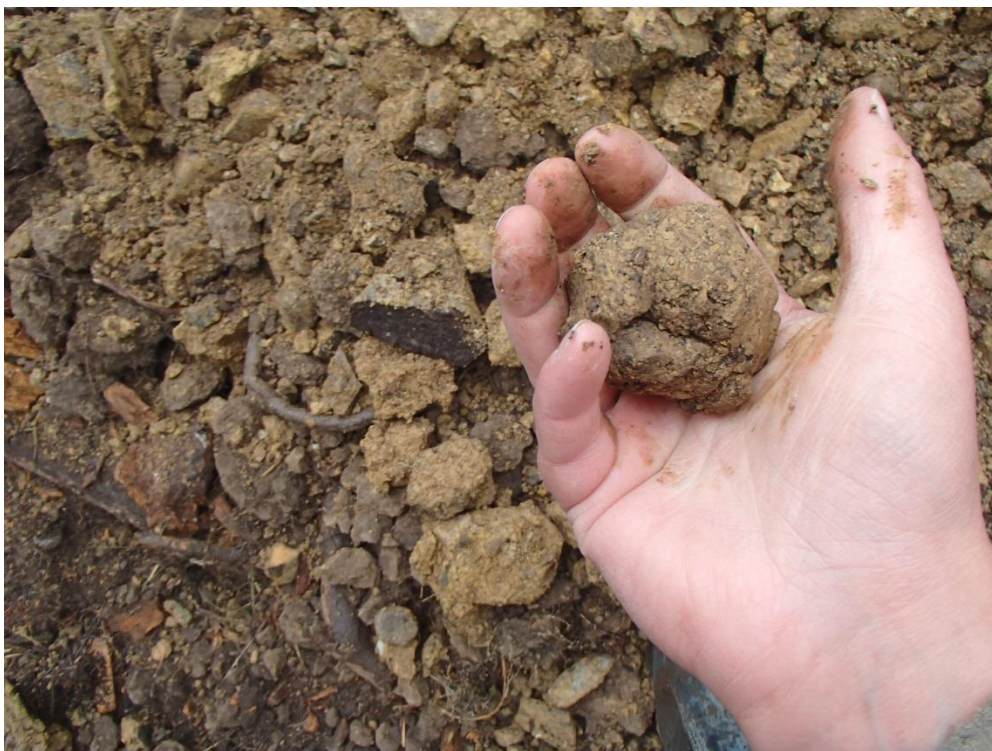
DW\_ BA01

0-4 Soil (OL) organic silt/clay

4-25+TD light brownish orange-grey DW (CH) soft to stiff clay, moldable – good

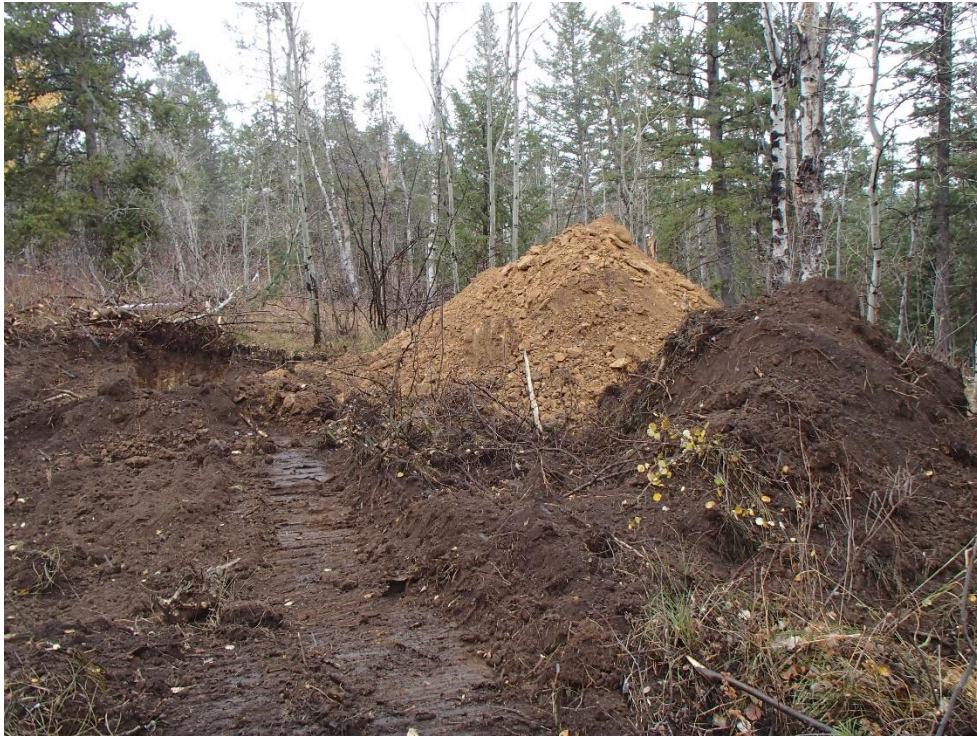
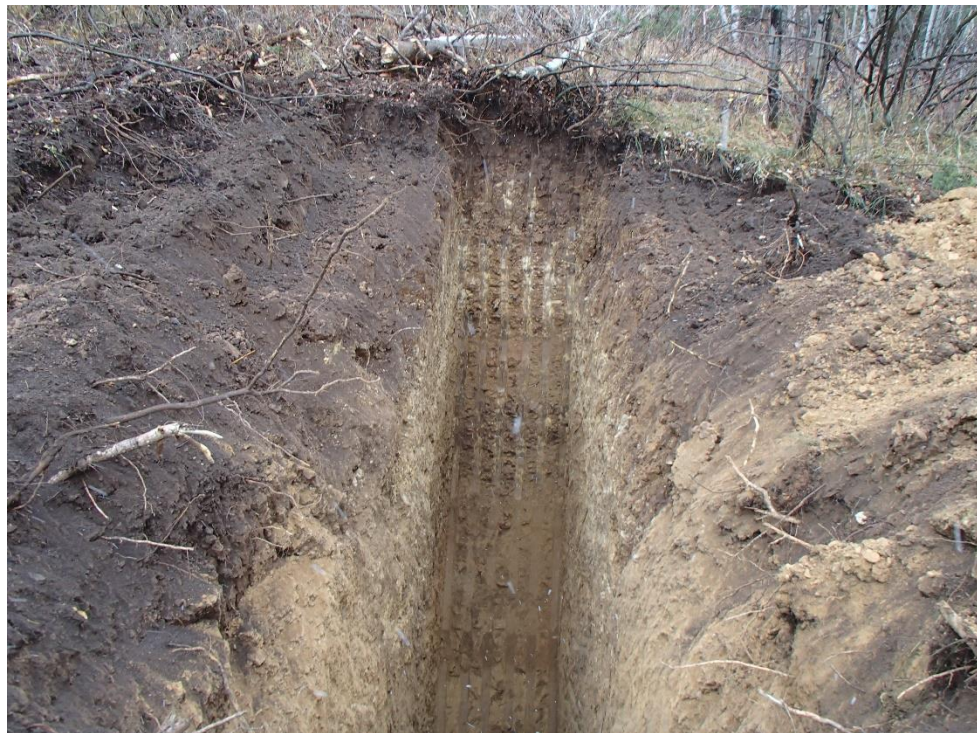
DW\_ BA02

0-4 Soil (OL) organic silt/clay

4-25+TD yellowish orange-tan DW (CH) very stiff to hard clay, platy – good

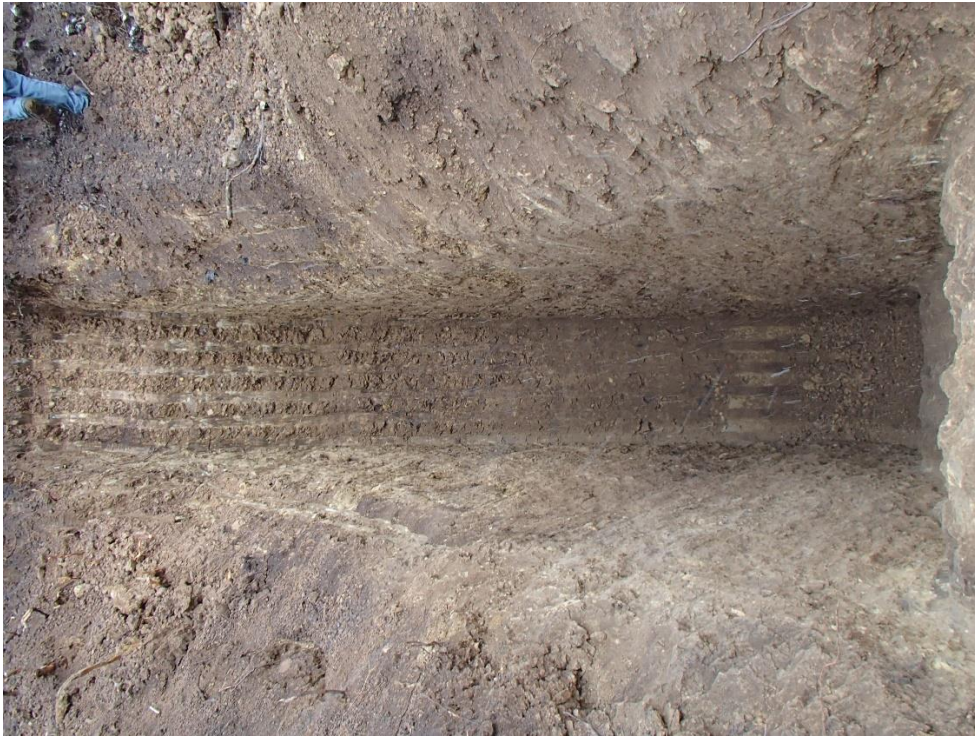
**DW\_ BB01**

0-3 Soil (OL) organic silt/clay

3-15 yellowish-orange DW (CH) Stiff Clay – good

15-25+TD olive-grey DW (CH) Stiff/Very Stiff to Hard Clay – good

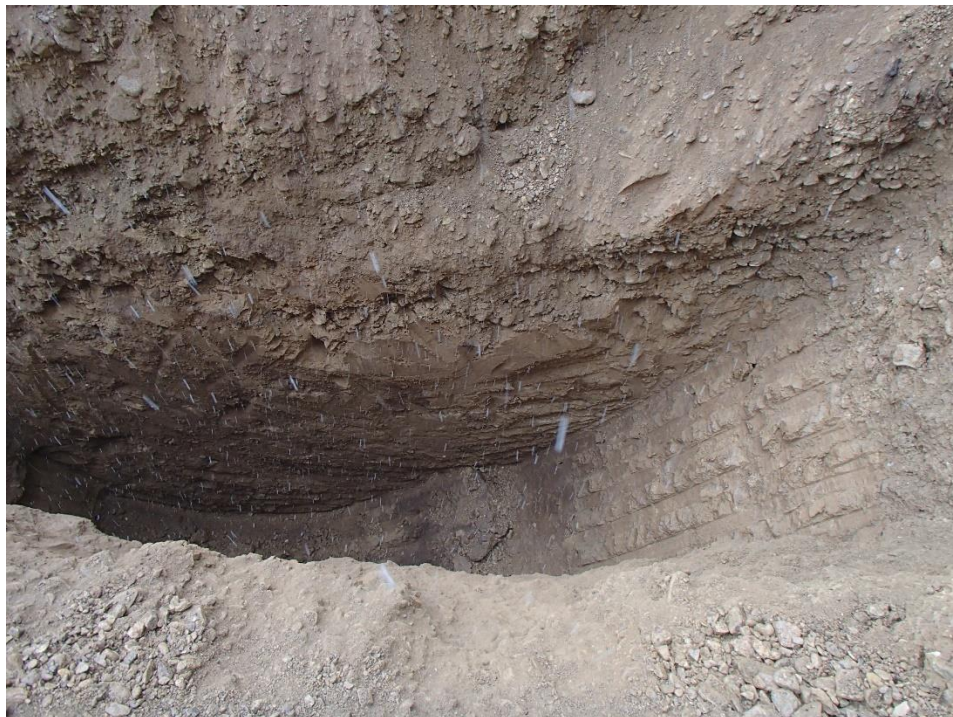
**DW\_ BB02**

0-5 Soil (GC) clayey gravels/ sand-clay mixture

5-10 well rounded (GC) mixture cobbles –gravel/clay – poor

10-25+TD light brown DW (CH) Stiff to Hard clay – good

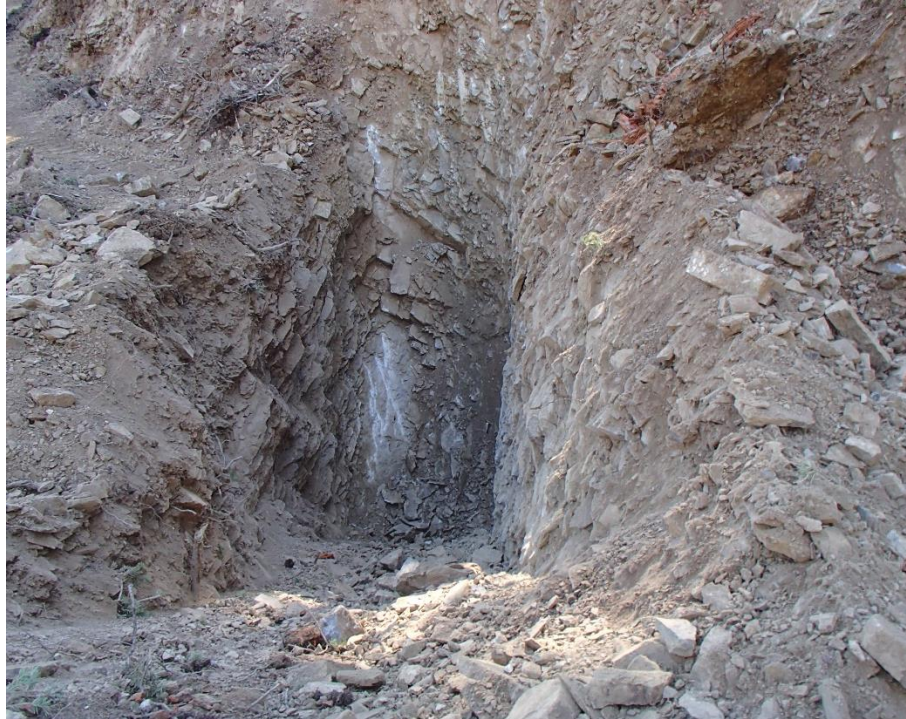
DW\_ DA01

0-2 Soil (GC) light brown angular clayey gravels, fine sand-clay mixture

2-22+/-TD dark brown-red staining/dark grey rocky DW shale/limestone boulders/cobbles – bad

Refusal @ TD (broken ripper tooth)

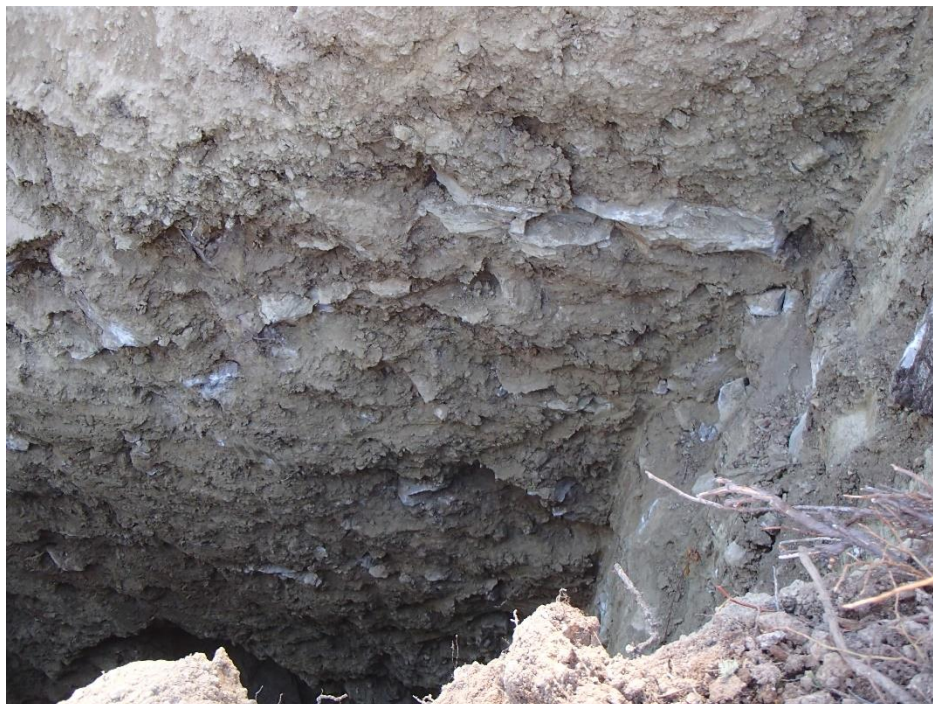
DW\_ DA02

0-3 Soil (GC) light brown angular clayey gravels, fine sand-clay mixture

3-15 light brown/light grey DW rocks, clayey matrix ~40% gravel, ~5+% cobbles – poor

Grades into boulder rocks at varying depth

15-20 light brown/light grey DW shale/limestone rock –bad

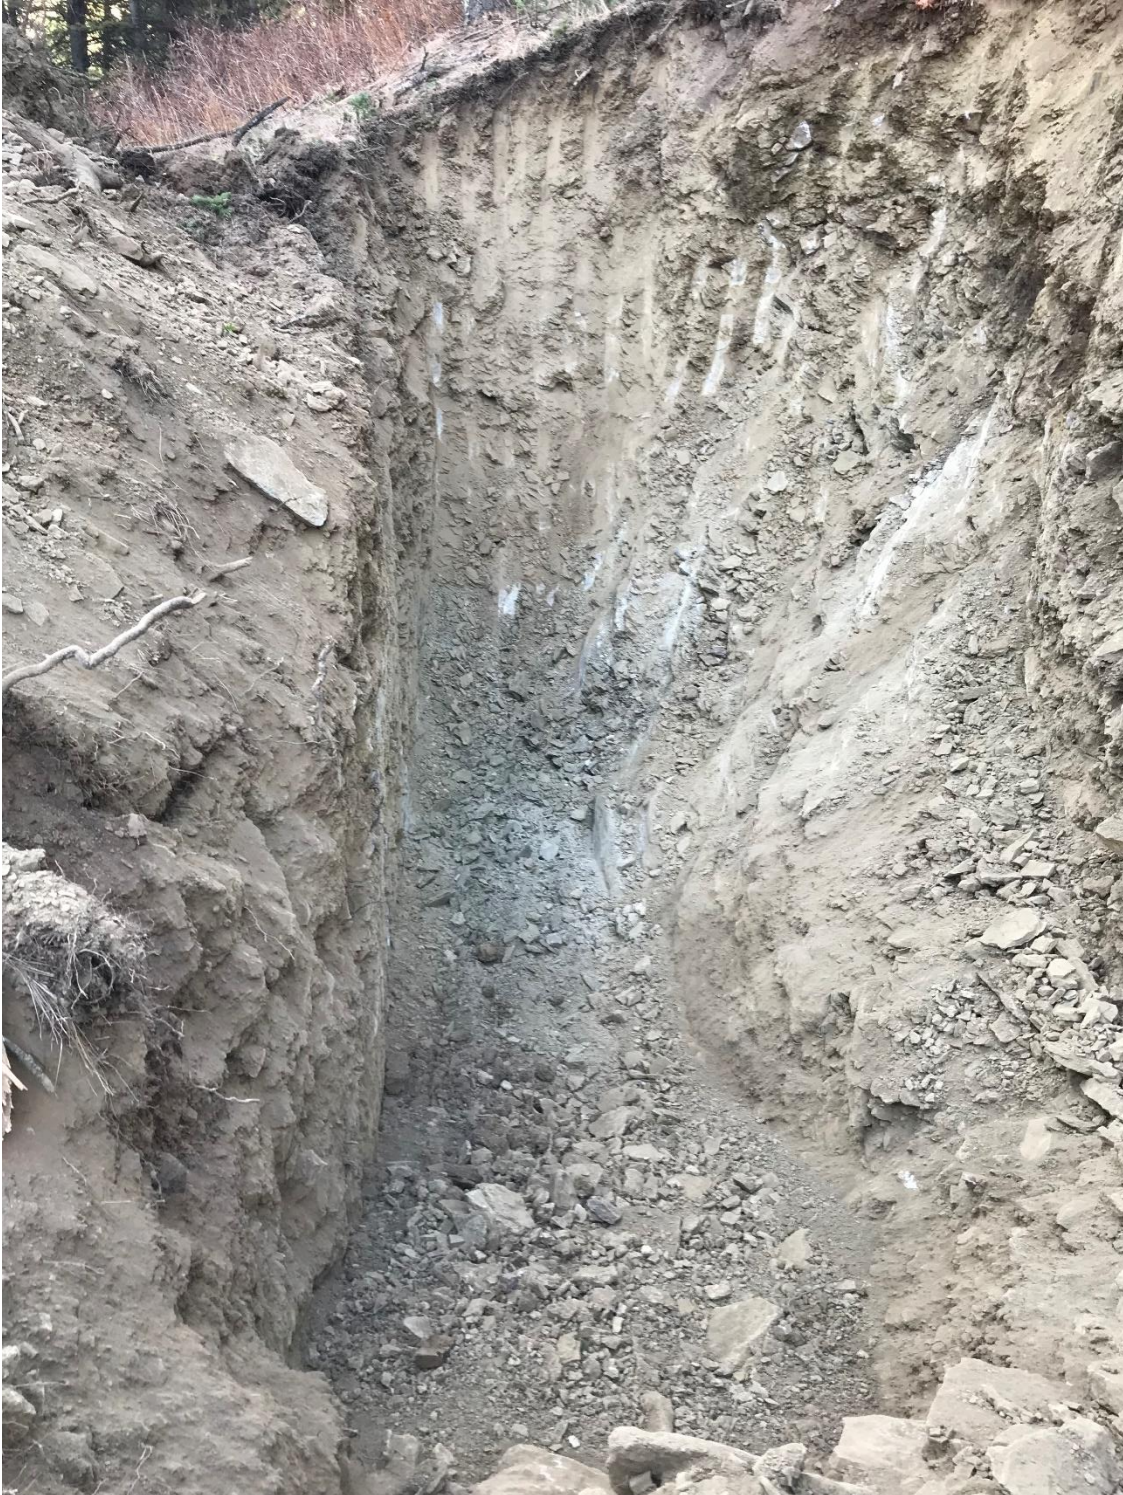
DW\_DA03

0-1.5 Soil (ML) light brown fine silty-clay mixture

1.5-5 light brown/light grey (GC) DW rocks, gravel-cobble in clay-silt matrix– poor

Grades into boulder size shale/limestone rocks

5-14+TD light grey/light brown DW shale/limestone rock –bad

Refusal @ TD (broken ripper tooth)

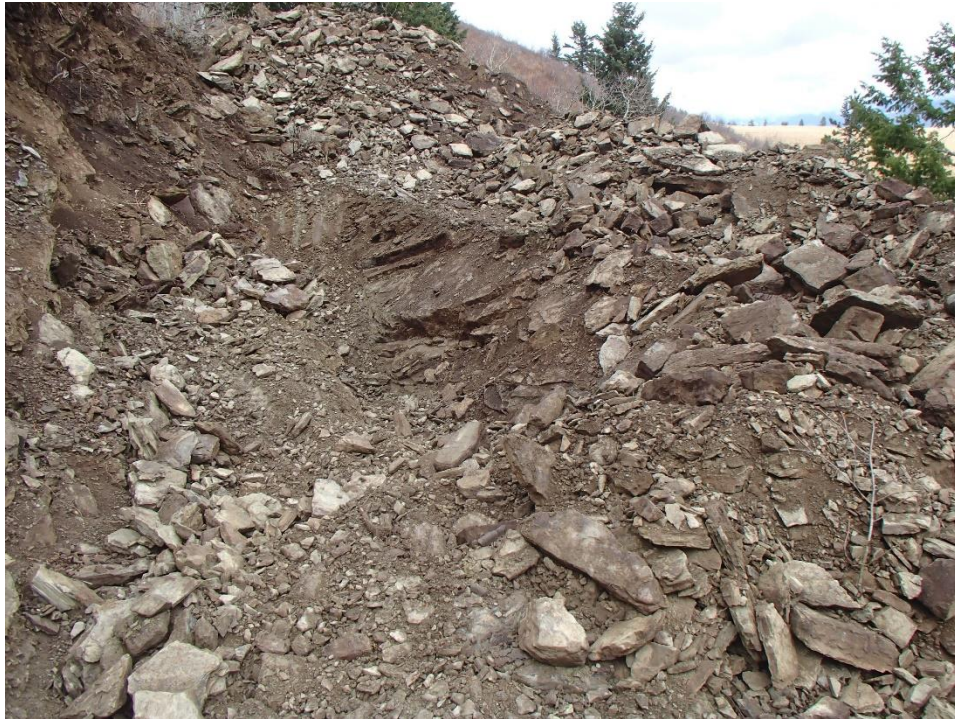
DW\_ DB01

0-2+ Soil (OL) dark brown fine silty-clay matrix

2-13+TD reddish brown/light grey DW shale/limestone rock – bad

10' from top of cut to pad plus 3' trench

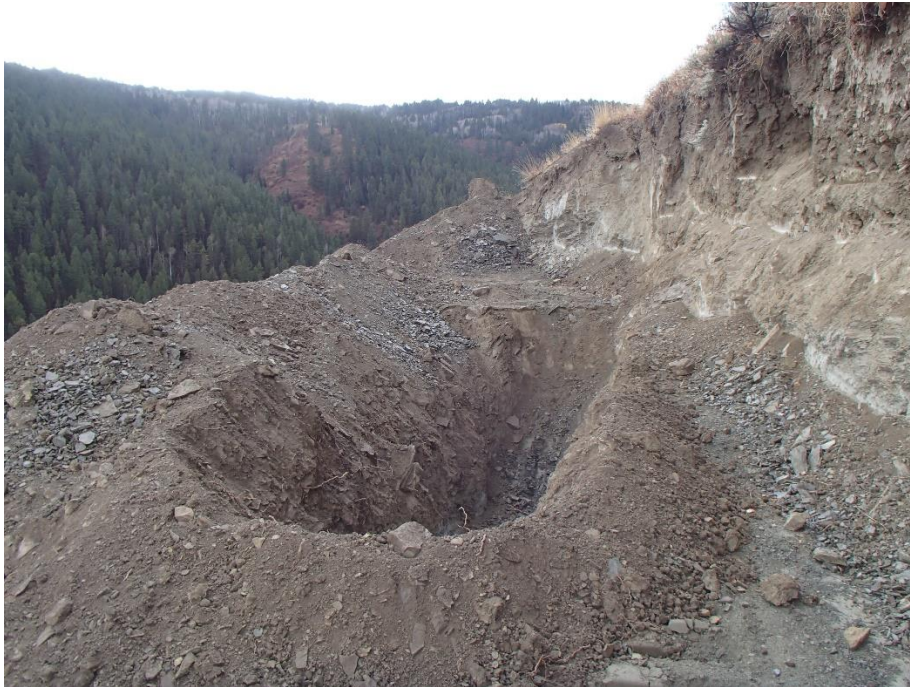
DW\_DB03

0-4+ Soil bottom of roots (GC) light brown fine silty-clay matrix with gravely shale rock

4-7+TD yellowish/orange and light grey DW shale rock, interbedded seams of dark red-brown limestone rock– bad

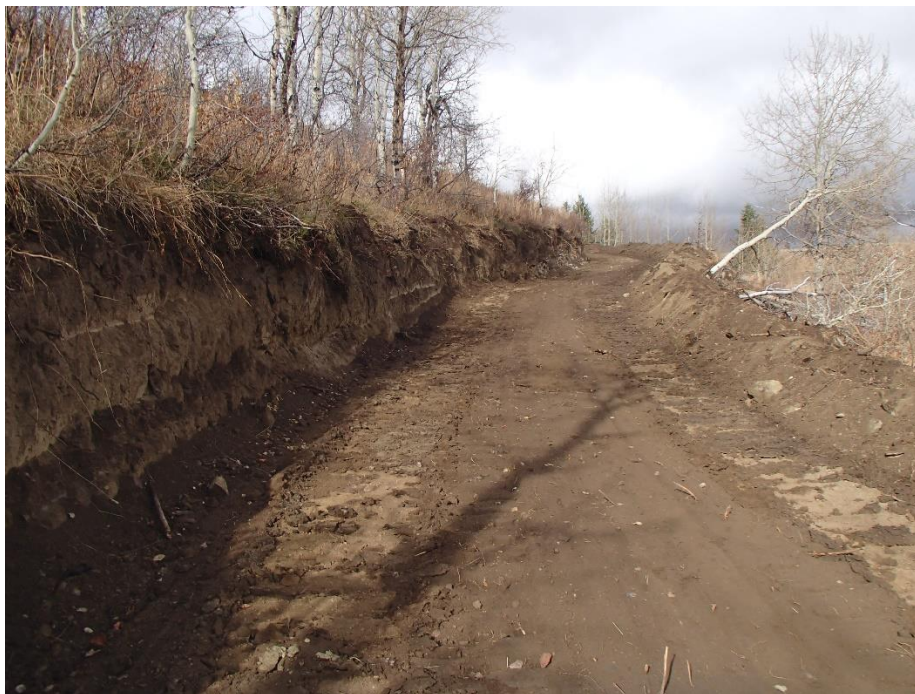
D-Panel Borrow B Road Cut

Additional note: half of the first switch back looked to have up to/ at least 5 feet of decent fine grain clayey material in the road cut. This is only present lower on the slope/switchback and full east facing slope. The south facing slope has significantly more hard silty shale with low plasticity and clay content, an apparent contact for this material type around the edge of the slope appears to be parallel with the pillar like cliff outcrop overlooking Sage Creek below the D boneyard.

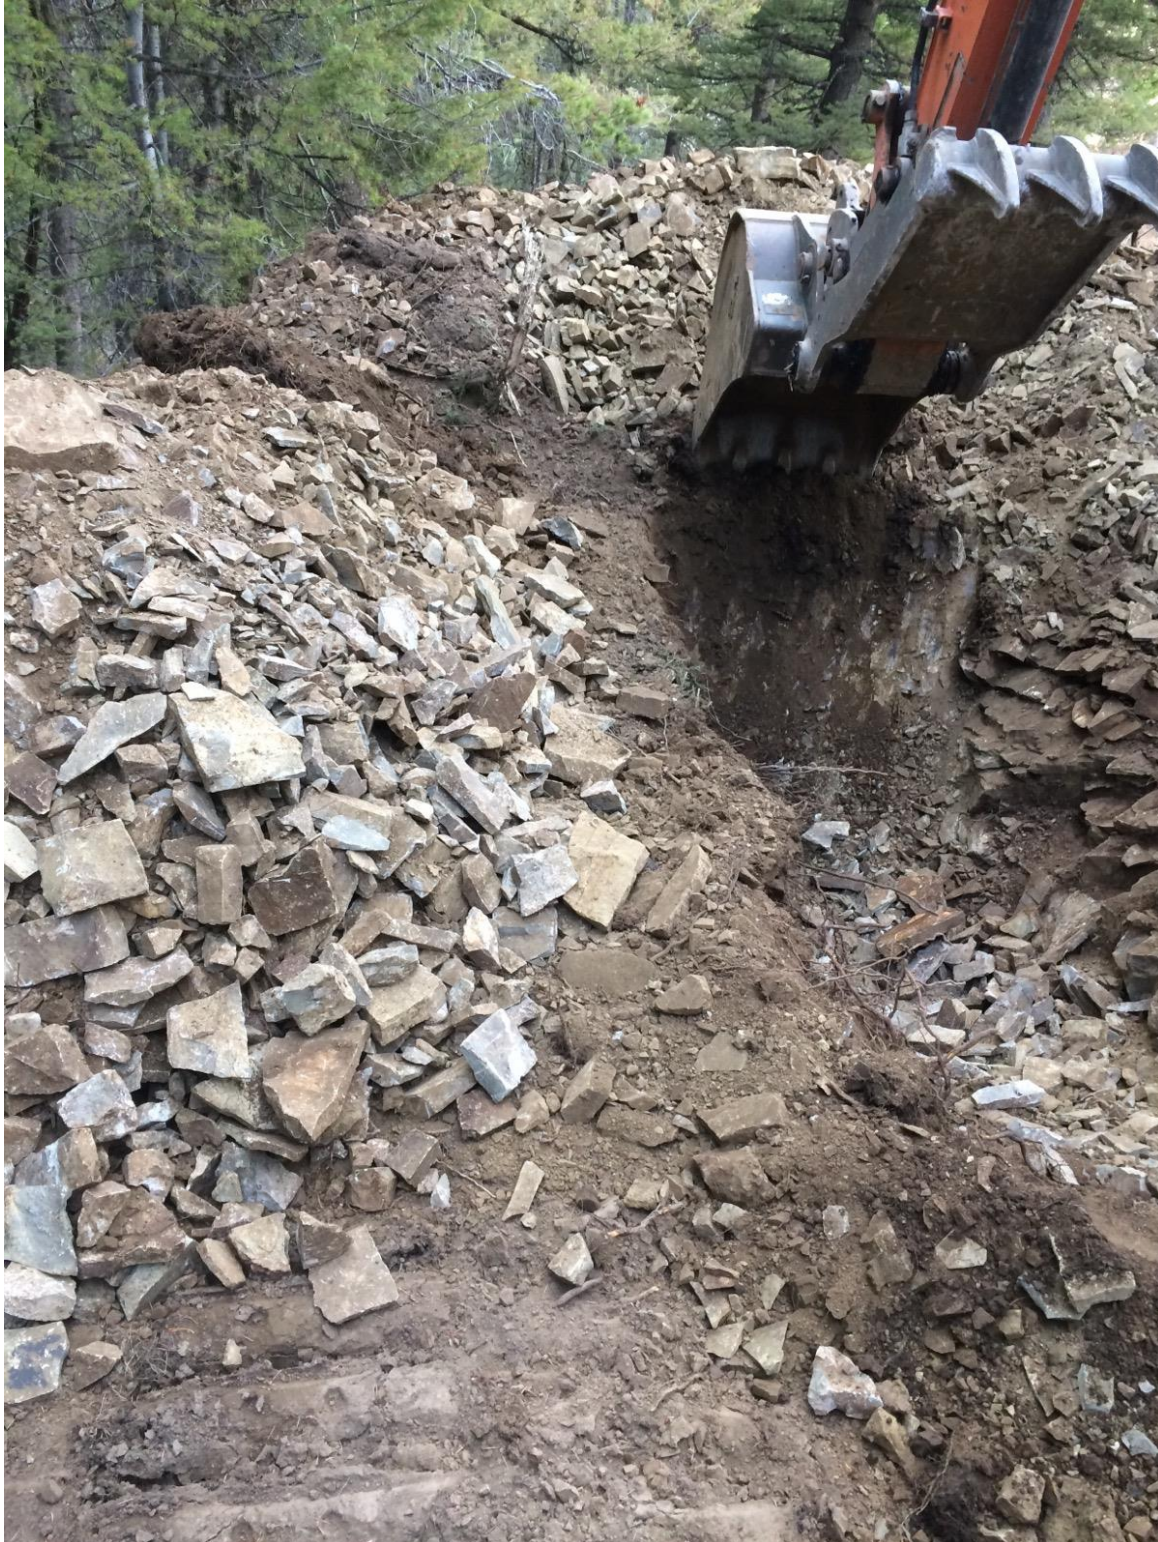
DW\_ EA01

The excavator operator encountered hard rock and abandoned the dig at the surface on 10/29 and 10/30 at DW\_EA01 and DW\_EB02 respectively.

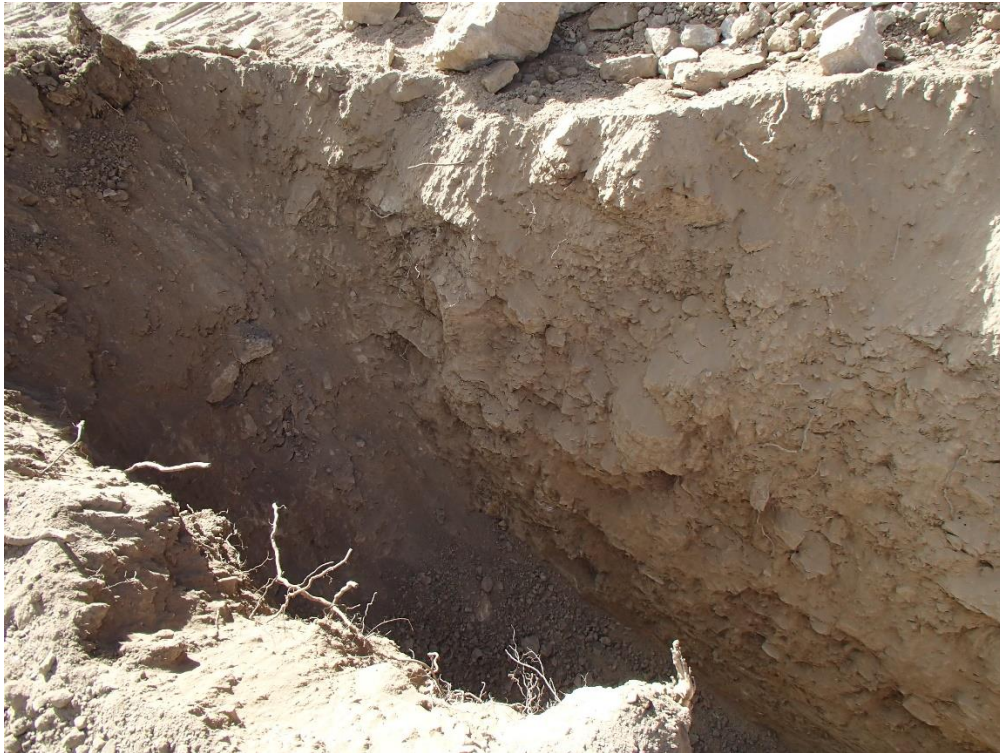
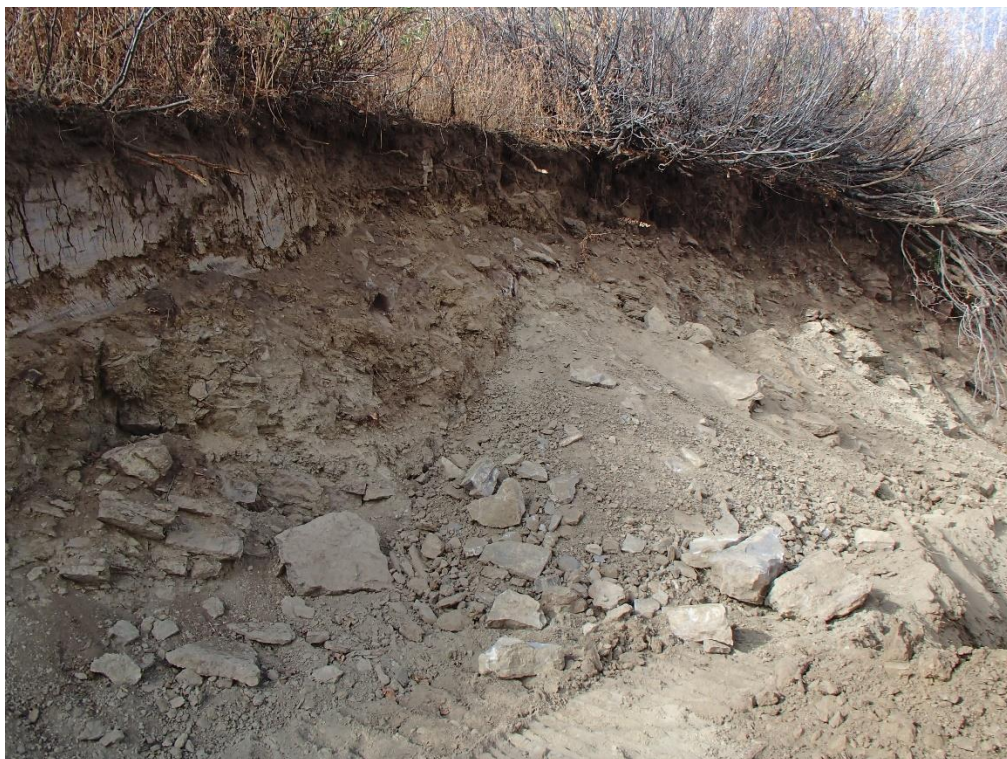
DW\_EA02

0-3 Soil with plasticity and roots (OL/GC) light reddish brown fine silty-clay matrix with some gravel

3-8 light brown and grey large DW shale/limestone rocks – bad

8-16+TD (GM) light brown and grey DW shale rocks in low plasticity silty matrix, interbedded seams of dark red-brown limestone – poor

8' from top of cut to pad plus 8' trench

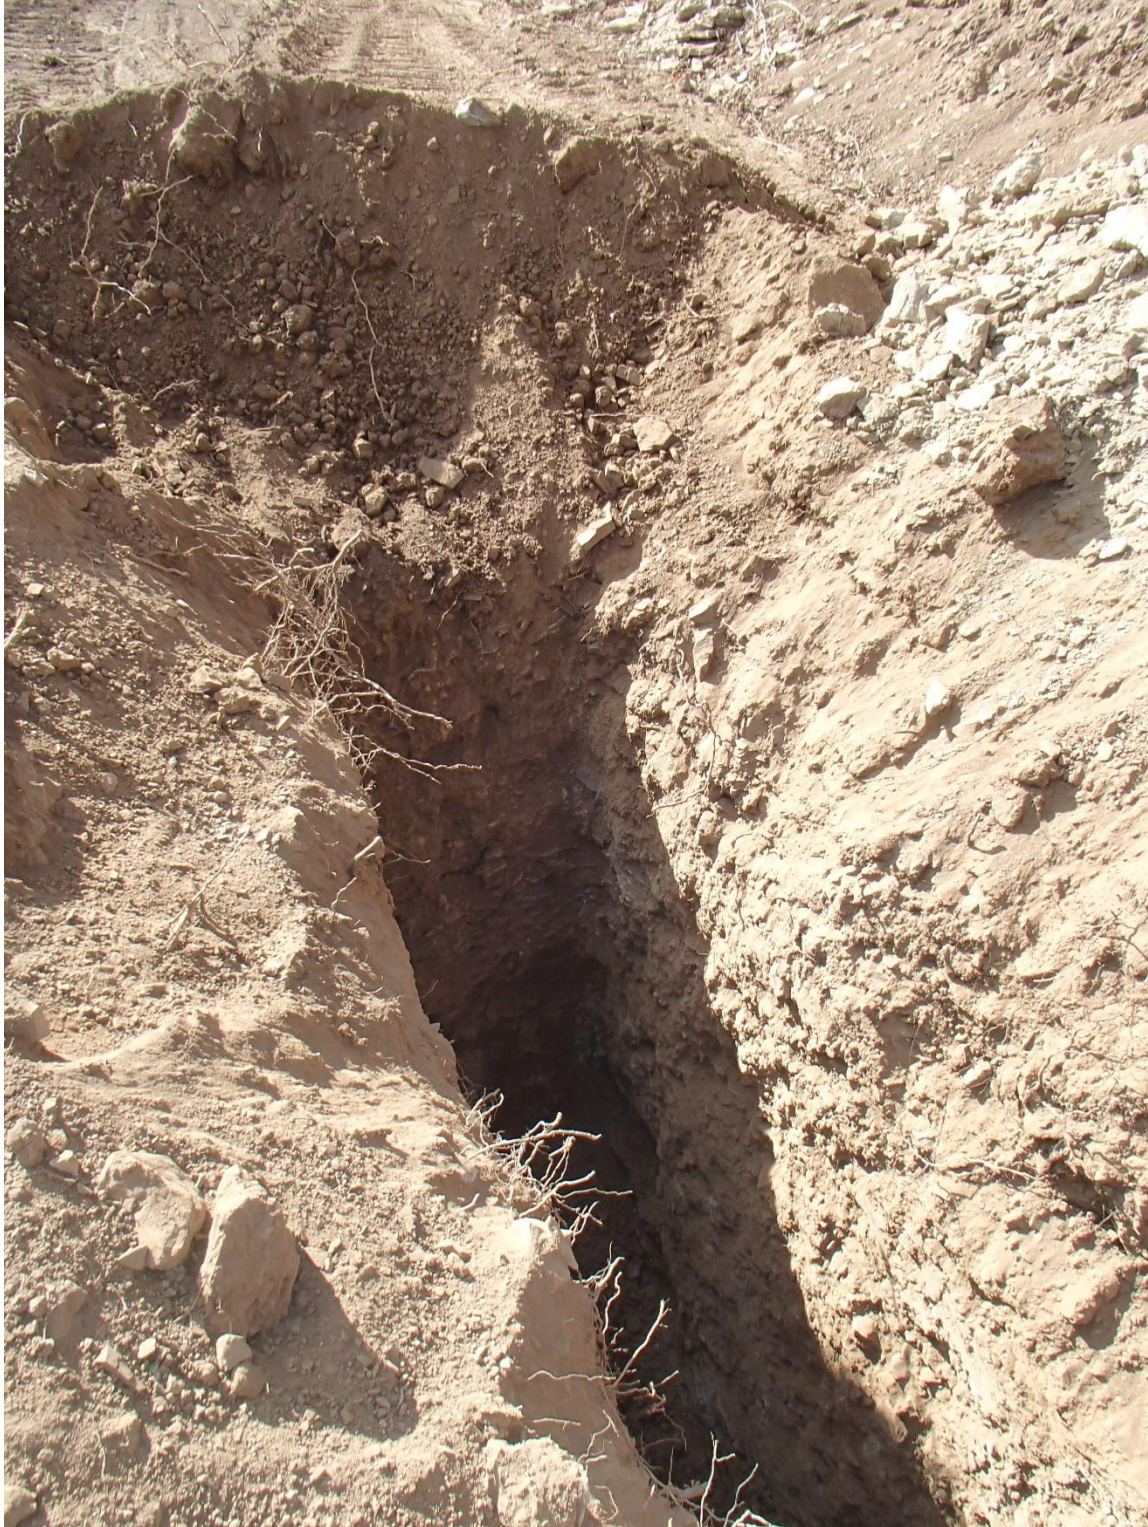
DW\_EB01

0-3 Soil with roots (OL/GC) reddish brown fine silty-clay matrix with gravely shale rock

3-21+TD (GM) light reddish brown silty matrix and interbedded light grey DW shale rock– poor

9' from top of cut to pad plus 12' trench
